TALGO, INCORPORATED

NTSB Accident Number: RRD-18MR001

Proposed findings in relation to the behavior of the railroad rolling stock involved and recommendations for improved safety in connection with the derailment of Amtrak Train 501, DuPont, Washington, Dec. 18, 2017

FINAL SUBMISSION

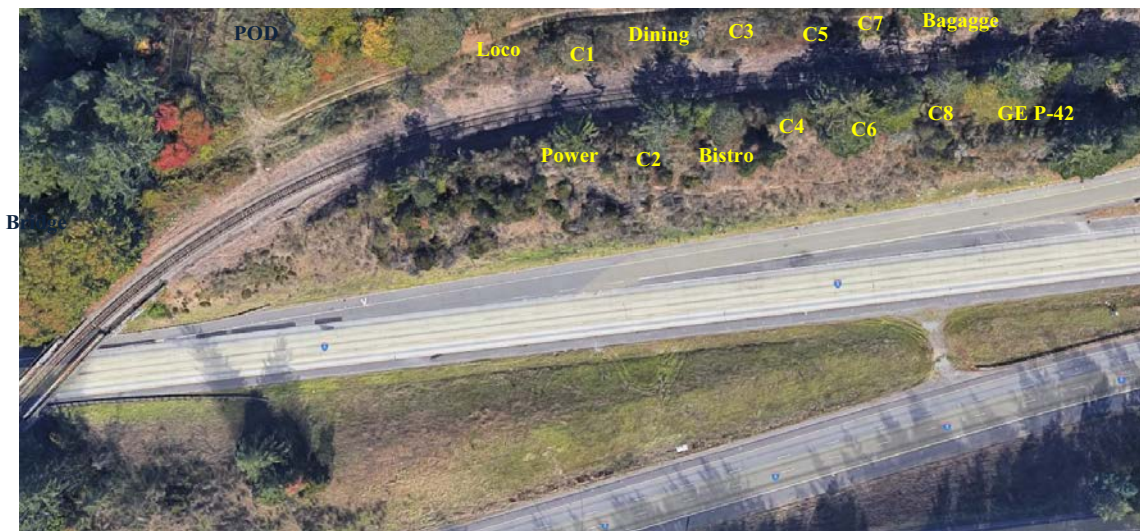
Figure 5 Point of Derailment

When it reached the curve, the locomotive derailed to the high side, slipped off the right side and rolled to its right until it reached a point next to the bridge. At that point it righted itself, returning to vertical. Figure 6 shows the state of the locomotive after the accident, displaying evidence that it was sliding on its right side.

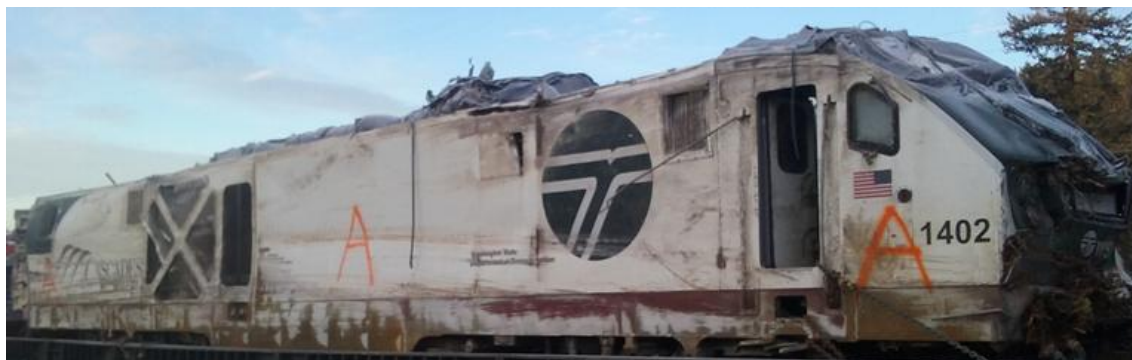
Figure 6 Locomotive condition after the accident (right side)

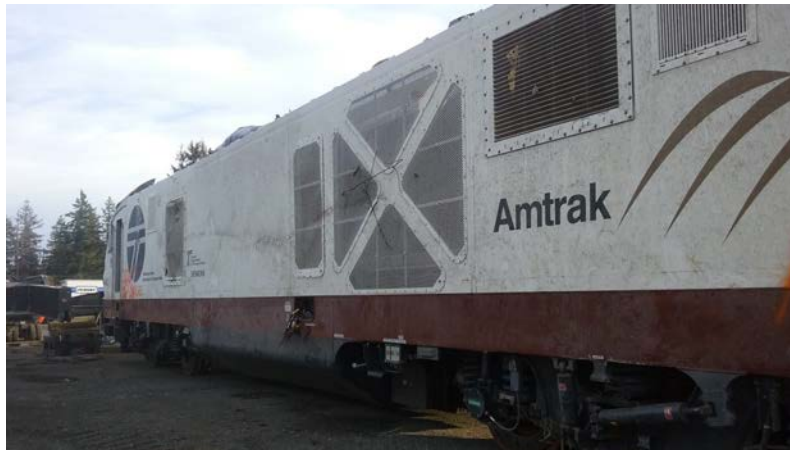
Figure 7 Locomotive condition after the accident (left side)

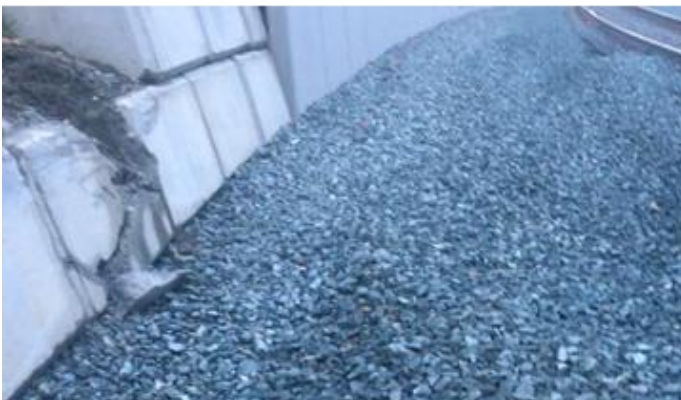
Figure 8 and 9 show evidence of impact of the locomotive against the retaining wall to the right and the distant signal for the Nisqually control point, MP 21.3. (The debris at the right in Figure 8 is from the signal.)

Figure 8 Retaining wall condition after the accident

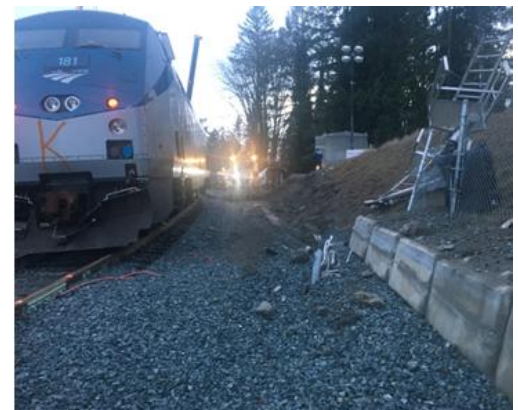
Figure 9 Wall and signal mast condition after the accident

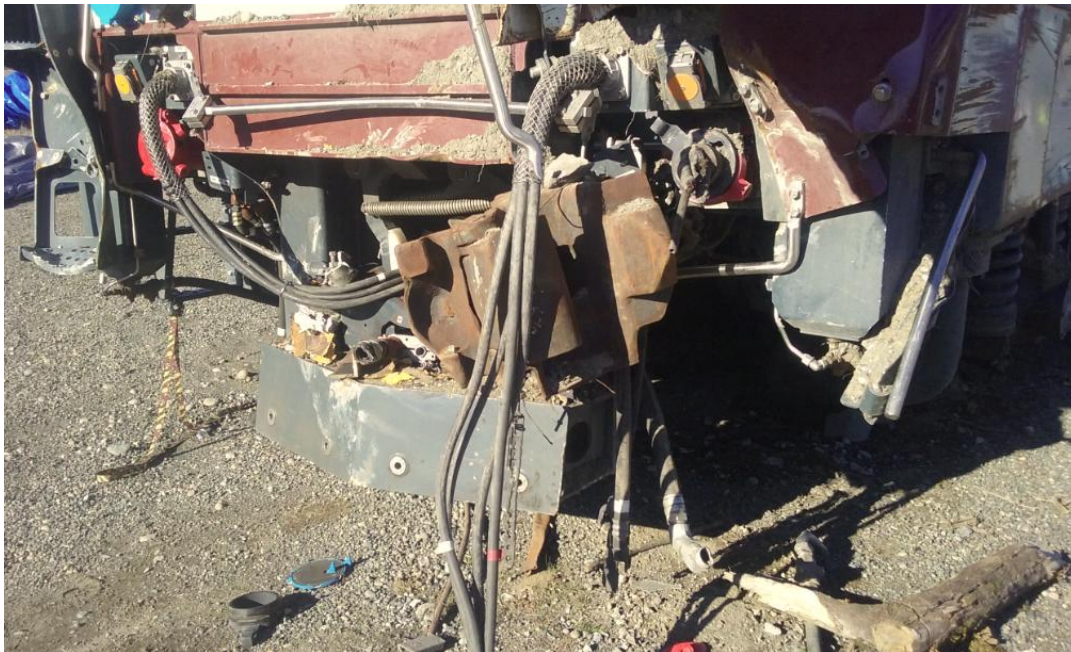
According to Talgo's dynamic calculations, due to their low center of gravity, the Talgo cars could have run through this curve at this speed without overturning. Further evidence (in addition to engineering calculations) supporting the belief that the locomotive had turned on to its side was provided by physical inspection of the damaged equipment during March, 2018, at Joint Base Lewis-McChord (JBLM). Ballast and dirt were found inside the right side of the locomotive, and drag marks were clearly visible on that side, indicating that the locomotive was on the ground during the accident.

Figure 10 Detailed view of locomotive coupler

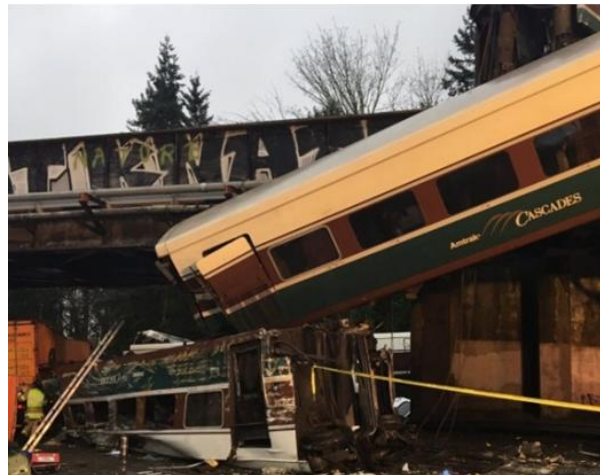
C7 7421 rests on C4 7424 (upside down under the bridge)

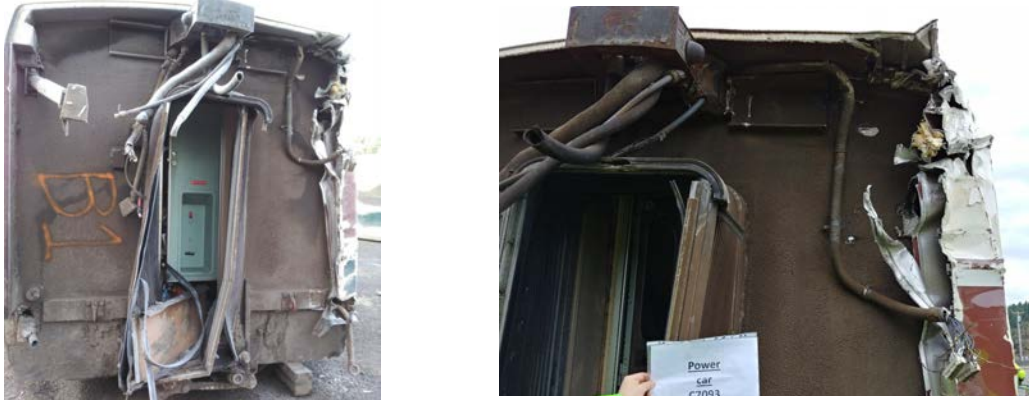
During the accident power car 7903, C1 7454, C2 7554, dining car 7804 and bistro 7303 suffered in-line collisions confirming that Talgo trains distribute deformation along the train as anticipated in the Arthur D. Little report. The pictures that follow show evidence of the in-line deformations.

Figure 31 power car 7903. car to car interactions

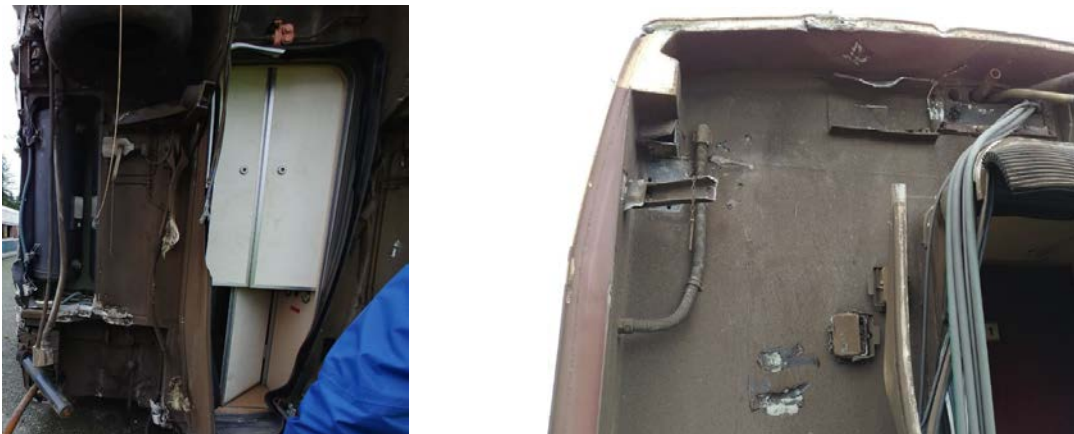
Figure 32 C1 7454. Car to car interactions

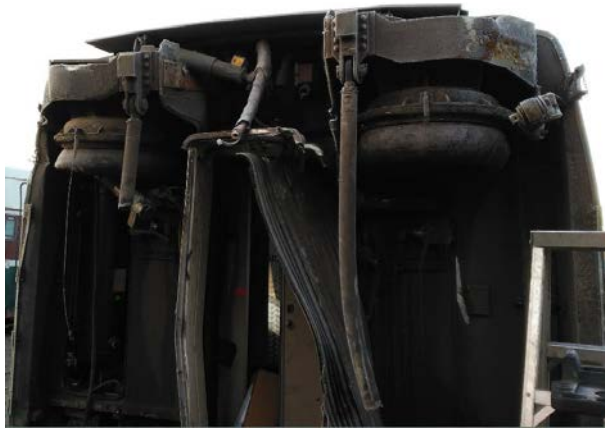
Under the loads indicated in CFR the most critical condition is the buckling failure of the bars. This condition was apparent in several cars such as diner 7804, bistro 7303 and C5 7423. This effect is shown in Figure 39 to 41, where no failures of attachments are detected but severe deformations of suspension tower supports did occur. These deformations show that the forces produced during the accident greatly exceed the 100,000 pounds required by the current regulation.

Figure 39 diner 7804 weight bearer bar buckling

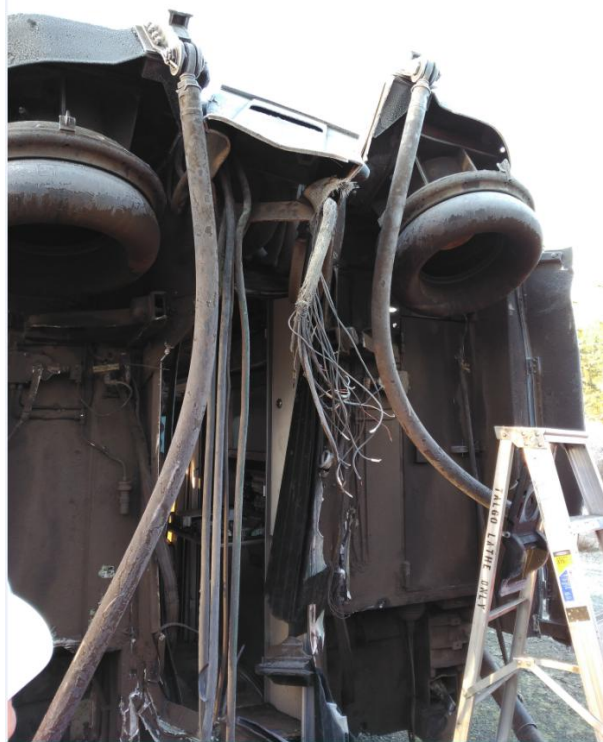
Figure 41 C5 7423 weight bearer bar buckling

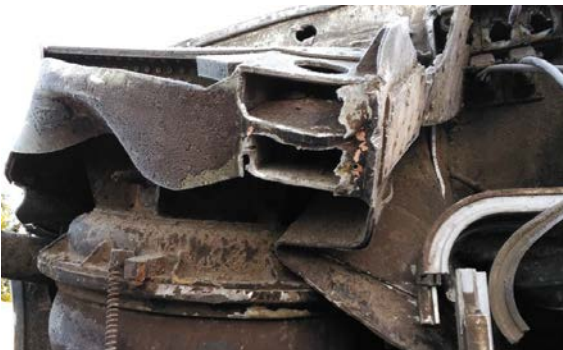
In some cars the aluminum plate where the weight bearer bars were attached had been torn off from the tower support. This failure was caused by very high forces as can be inferred from Figure 43 and 44, where the car body structure was severely deformed by these vertical loads.

Figure 43 C7 7421 tear off detail

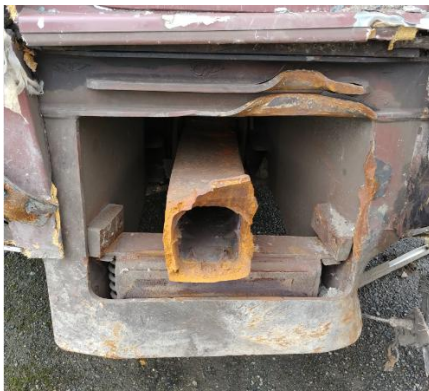
The couplers on Talgo end cars are Type H Tightlock couplers in accordance with AAR (now APTA) standards (Talgo Technical Specification ET-0213). This coupler on power car 7903 was broken due to the forces produced when the buff forces (produced by the decelerating locomotive) caused lateral forces that rotated power car 7903. Post-accident inspections reveal deformations consistent with torsional and bending loads in the power car and the locomotive. Figures 45 and 46 show torsional and bending deformations on the power car coupler. Figure 47 and 48 show the torsion effects on locomotive coupler.

Figure 45 Power car 7903. AAR coupler (1)

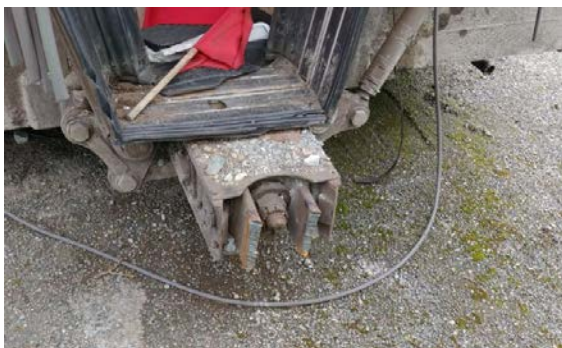
Articulated connections were subjected to various types of loads depending on the car to which they were attached. The articulated joint between power car 7903 and C1 7454 was broken due to the rotation of the power car described in 2.4.5 above. For the connections between C1 7454, C2 7554, diner 7803 and bistro 7303, the couplers were subjected mainly to compressive forces, and it was necessary to cut off the bolted supports to release the cars.

Figure 49 C1 7454. Coupler detail supported end

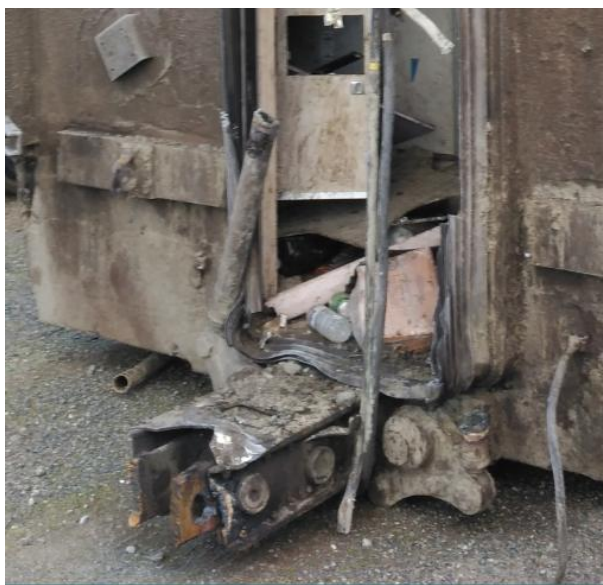
Figure 51 diner 7804. Coupler detail suspended end

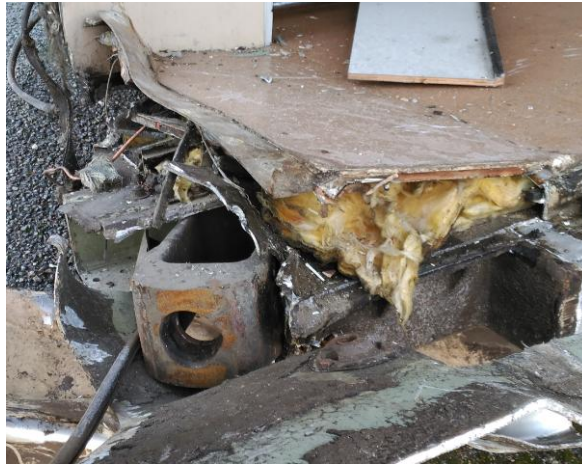
According to the accident sequence described in 1.2, the coupler between bistro 7303 and C3 7504 broke when the cars ahead of C3 7504 decelerated and the cars behind it, still on the track, kept pushing. Figure 52 shows the effect of the very high forces that broke the beam to which the coupler is attached.

Figure 52 C3 7504 Coupler detail, supported end

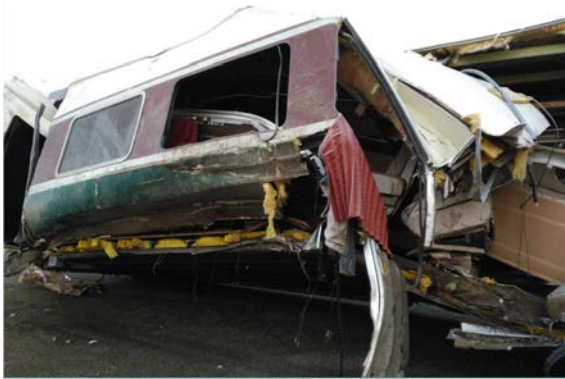
According to the accident sequence described in 1.2, C3 7504 received a high speed side impact against the overpass approach fill retaining wall, causing extensive damage at that point (and possible immediately following this collision). As can be seen in Figures 53 through 56 below, this extensive damage could not have been produced by the truck that detached from C6 7422, three cars to the rear, but it could have easily been produced by impact with the concrete wall. One block from this wall, which was partially demolished by the impact for the train, is visible immediately to the left of the detached truck in Figure 56. All three deceased passengers were in this car.

Figure 53 C3 7504. Side impact evidence (1)

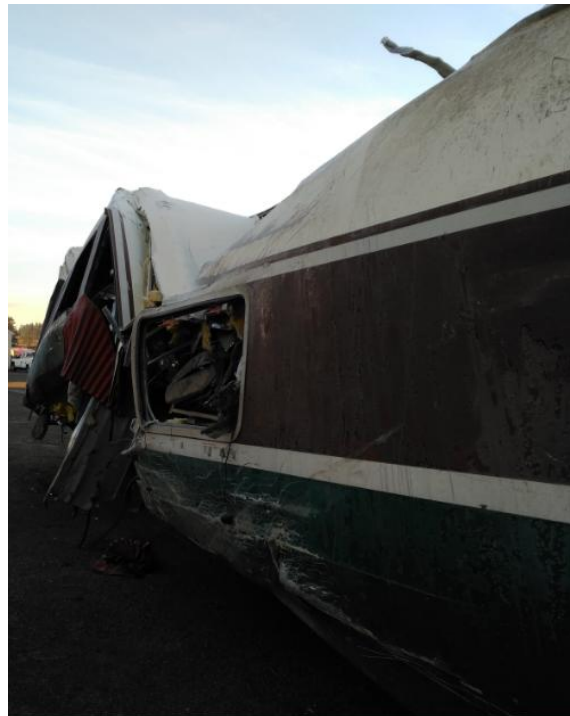
Figure 55 C3 7504. Side impact evidence (3)

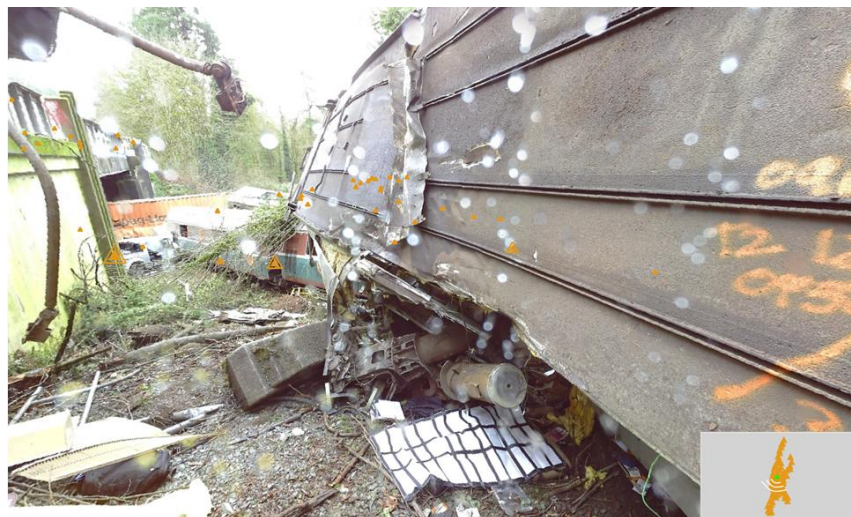
Figure 56 C3 7504. On site

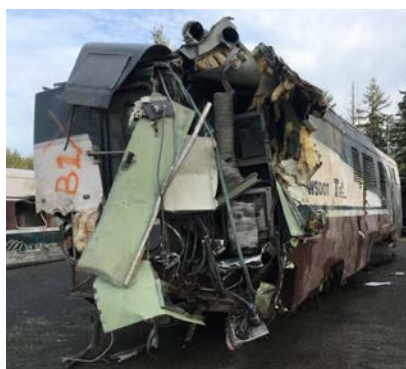
While severe damage to the end fairing of power car 7103 was apparent during the inspection at JBLM, the steel structure that forms the collision posts was found to be undamaged. (See Figures 61 and 62)

Figure 61 7903 Power car. End detail (1)

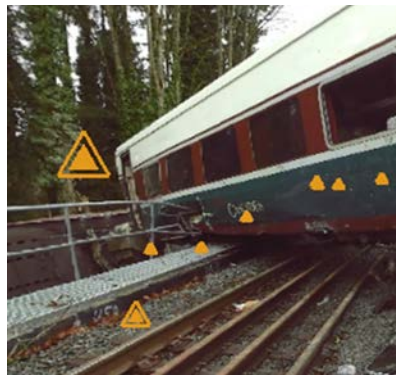
According to the investigation, some seats rotated due to various causes, but no defects attributable to design or maintenance were found. In C5 7423 the root cause was the lateral collision against the overpass. Metal debris from the bridge was found in this car. That damage caused the rotation of some seats, some of which were actually fixed (non-rotating) seats. In C4 7422 and C2 7554 rotated seats were examined with no defects found.

Figure 63 C5 7423 Metal debris intrusion

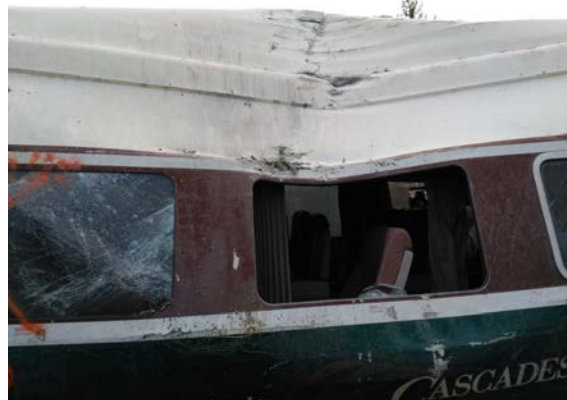
The rotation of seat 4C in C2 7554 was clearly caused by the deformation of the left side after C3 7504 came to rest on it. That deformation is clearly visible in Figure 64.

Figure 64 Left side deformation of C2 7554

Deformation of the sides broke the seats loose from their bases, allowing them to rotate; no defects of the attachment of the seat bases to the car body structure were found.

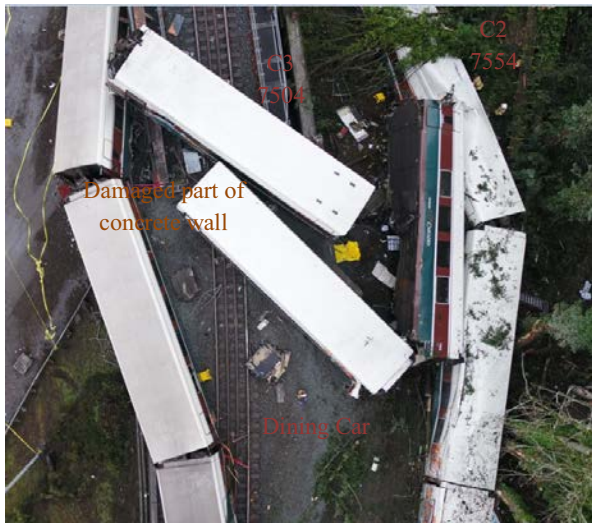
Figure 80 C3 7504. Final position

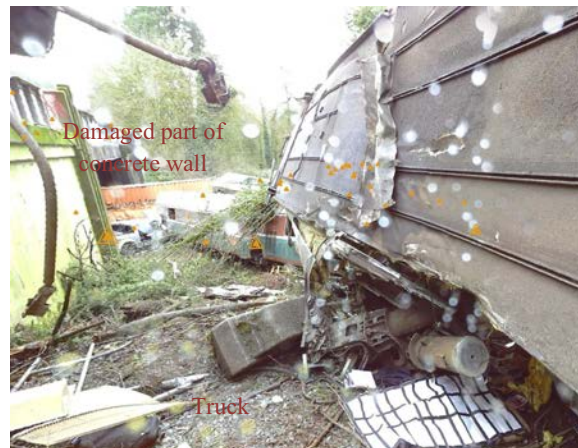
Figure 81 C3 7504. On site view

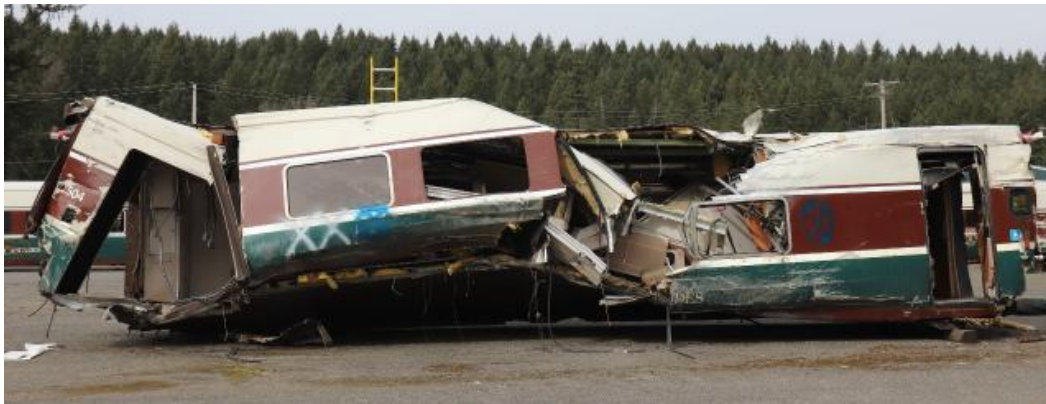
Figure 82 C3 C7504 damage, left side

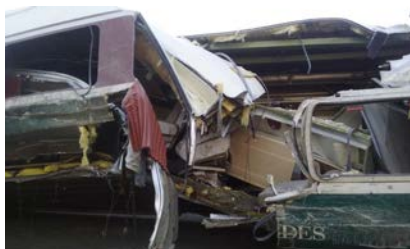
Figure 84 C3 C7504 damage, left side, detail (1)

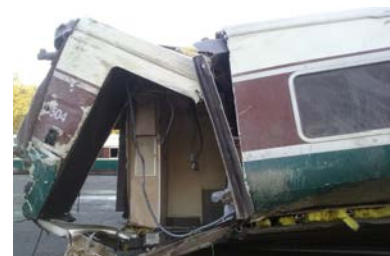
Figure 85 C3 C7504 damage, left side, detail (2)

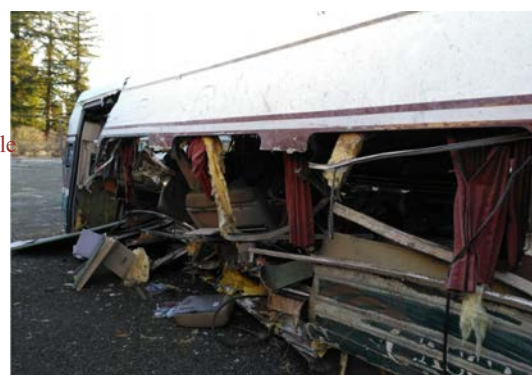
At the bridge entrance, C4 7424 hit the walkway railing, generating the longitudinal cut observed on its right side (in the direction of travel). Under its own inertia and probably being pushed from behind, this car tore off a part of the bridge, falling down onto I-5. It turned upside down with the supported end towards the back and the suspended end forward. Due to the impact against the highway, this car's truck (RGG-0082) also fell onto I-5. It came to rest in the left lane under the bridge after being pushed there by a vehicle on the highway that struck it.

Figure 89 C4 7424. Right side damage

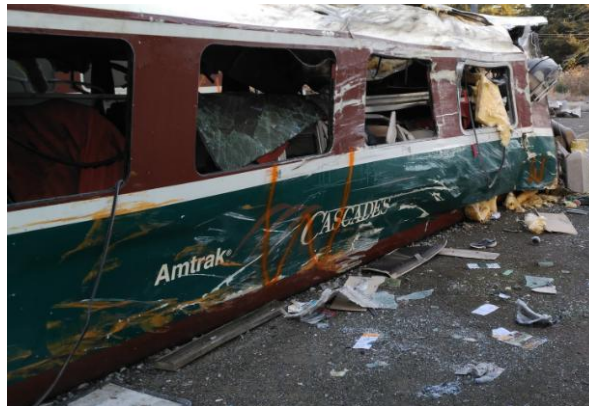
Figure 90 C4 7424. Left side damage

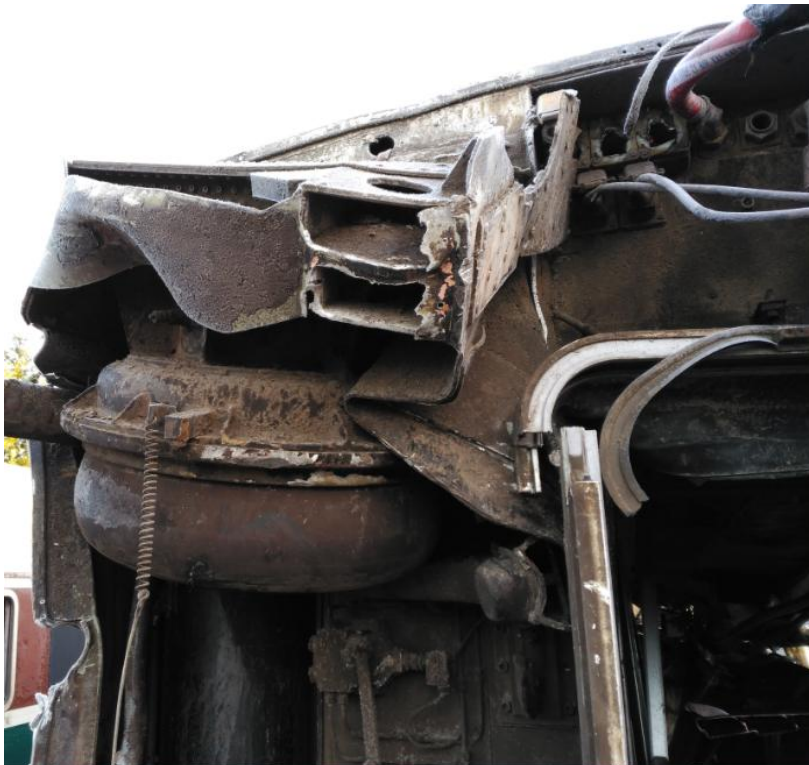
Figure 94 C4 7424 Deformation due to vertical impact

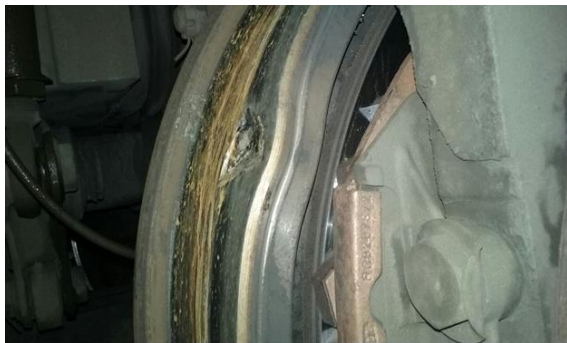
Figure 110 Damaged left wheel, rolling assembly car 6

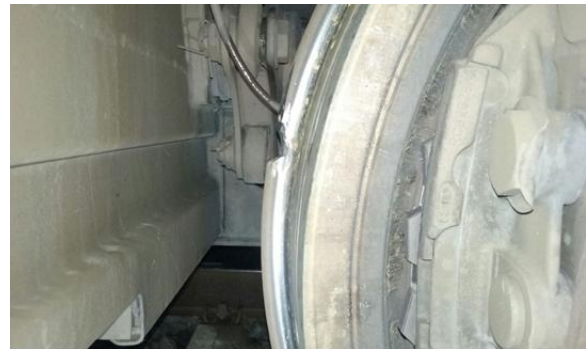
Figure 111 Damaged left wheel, rolling assembly car 7
